## 14<sup>th</sup>-16<sup>th</sup>-CENTURY DANUBE FLOODS AND LONG-TERM WATER-LEVEL CHANGES IN ARCHAEOLOGICAL AND SEDIMENTARY EVIDENCE IN THE WESTERN AND CENTRAL CARPATHIAN BASIN: AN OVERVIEW WITH DOCUMENTARY COMPARISON

Andrea Kiss<sup>1,2\*</sup>, József Laszlovszky<sup>3</sup>

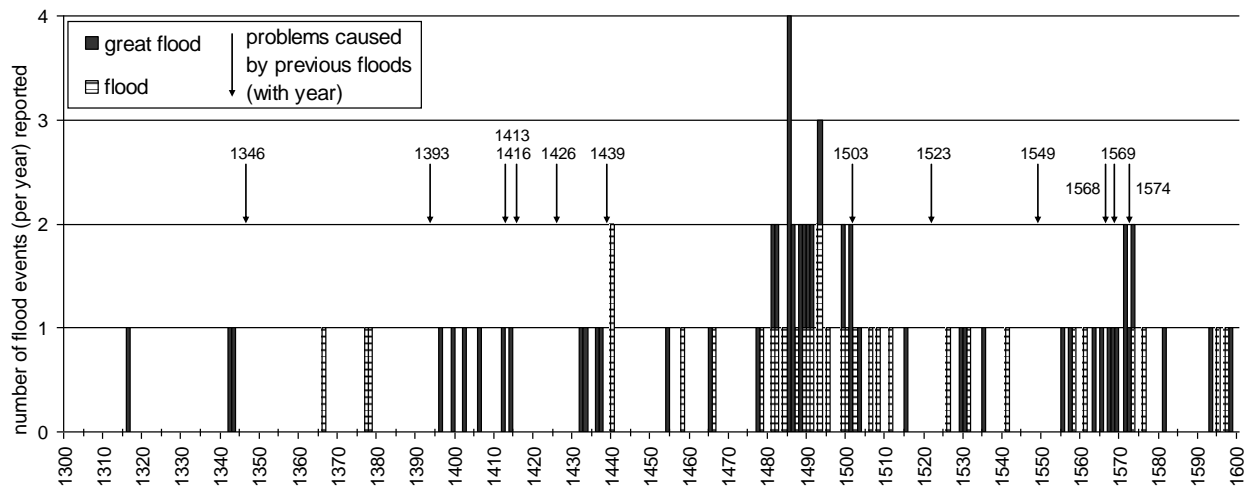
Fig. 1 14th-16th-century Danube floods in the Carpathian Basin, based on presently available documentary evidence (Sources: Kiss, 2012a, 2012b; Kiss and Laszlovsky, 2013)

Documentary evidence is mainly related to individual flood events or the relatively short-term consequences of preceding great flood events and therefore mainly provides high-frequency information. Archaeological and sedimentary evidence is mainly connected to the consequences of great or catastrophic flood events, flood-rich periods and long-term hydrological changes. Since dating of these events, periods and processes, with using natural scientific and archaeological methods, are usually possible on a multi-annual, multi-decadal level, archaeological and sedimentary data on floods are good indicators of medium- and low-frequency changes in flood behaviour. Nevertheless, documentary evidence can provide an important help in the possible more exact dating of flood events or flood peaks whose impacts could be observed in archaeological (and sedimentary) evidence (for presently available data, see: *Fig. 1*).

As a possible parallel, described in an official letter in 1549, short before the Danube at Bratislava also partly changed its bed, and floods were actively damaging the town walls (see Kiss, 1908; for more details see: Kiss, 2012b). Concerning this case, Ortway (1912) suggested that – similarly to the cases described by Fieber and his colleagues at Orth – an avulsion of the Danube channel occurred at Bratislava, and made the town walls (which were anyway in bad condition) more prone to destructive flood events. It is quite probable that this later event had connections to the great 1548 flood in Vienna mentioned above. Moreover, a number of flood events were also reported in contemporary documentation concerning the 1550s, and the great floods occurred practically in each year around the turn of the 1560s and 1570s (see Fig. 1).

The archaeological data on late 15<sup>th</sup>–early 16<sup>th</sup>-century floods is in good agreement with the information detected in documentary evidence: one of the most important (and certainly best documented) medieval flood peaks took place exactly around the decades of the 1480s, 1490s and 1500s (see Fig. 1).

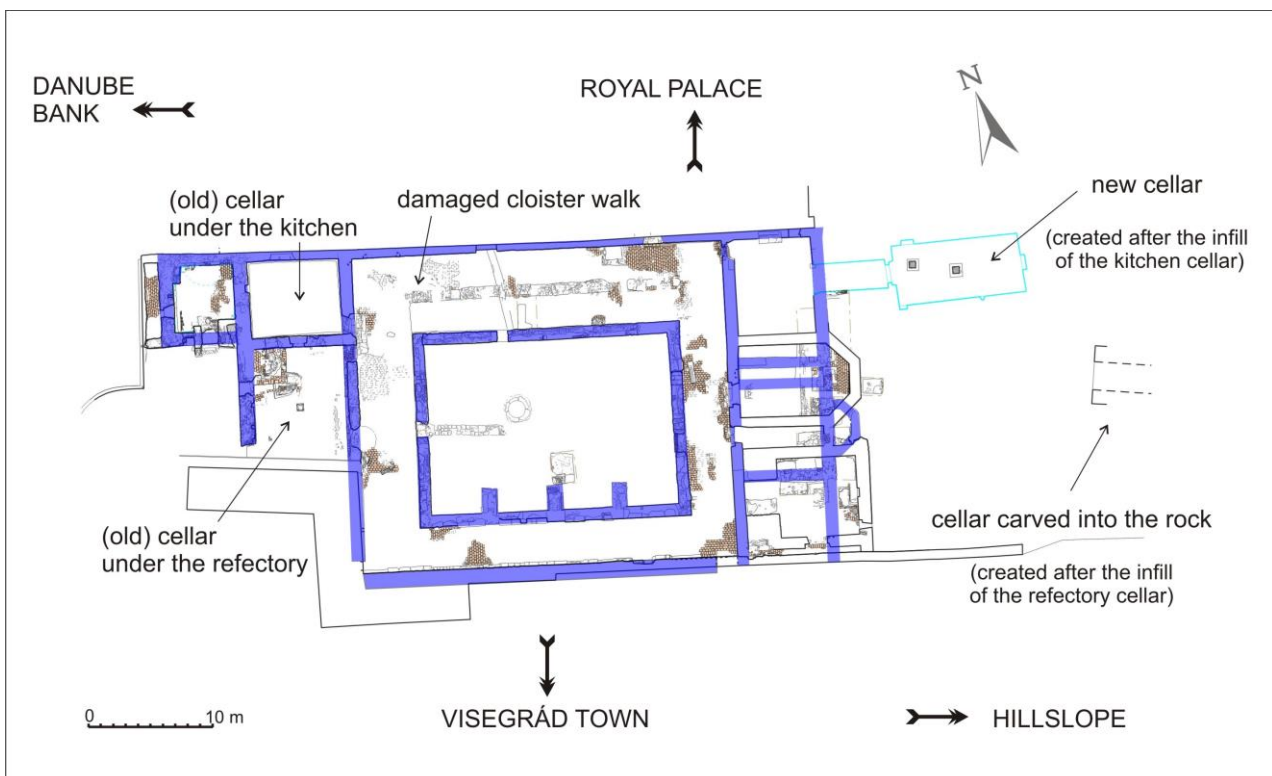
*Fig. 3* Layout of the excavated early 15<sup>th</sup>-century Franciscan friary in Visegrád

Two re-building phases were also detected during the archaeological investigation of the friary. One of them took place during the Matthias-period (1458-1490, with a building activity ca. 1470-80s), while the larger, almost total re-building of the complex happened during the first decade of the 16<sup>th</sup> century. During this new building phase, another significant rise of the ground level was initiated, which can be clearly detected in the layers of the cloister garth and under the pavement of the cloister walk. Already in this phase one of the two cellars in the western wing, under the newly constructed kitchen has been filled up with earth and a small new cellar was erected in the eastern wing of the cloister, close to the hill slope, behind the building complex (see *Fig. 3*).

Nevertheless, some time between these two dates, namely between 1514 and 1540 something (serious) happened in the environment of the friary, because one part of the building, namely the northern cloister walk (with pavement, pillars, vaulting etc.; for location, see *Fig. 3*) sank down with one meter, and because of this great change, the Gothic vault of the corridor has collapsed. When rebuilt, no vaulted structure was constructed, but most probably a simple horizontal wooden ceiling was used to cover the northern corridor. The infill of the for-

mer cellar under the refectory close to the Danube (western side of the friary), and the establishment of the other, new cellar far from the Danube (eastern side of the friary), carved into the rock of the hill presumably occurred in the same time. Based on these features, the location of the friary, the stratigraphy and morphological conditions of the area, the excavators presume that this major damage, occurred some time between 1514 and 1540, had strong connections with Danube floods happened around the same time, and also with the generally rising trend of Danube water levels.

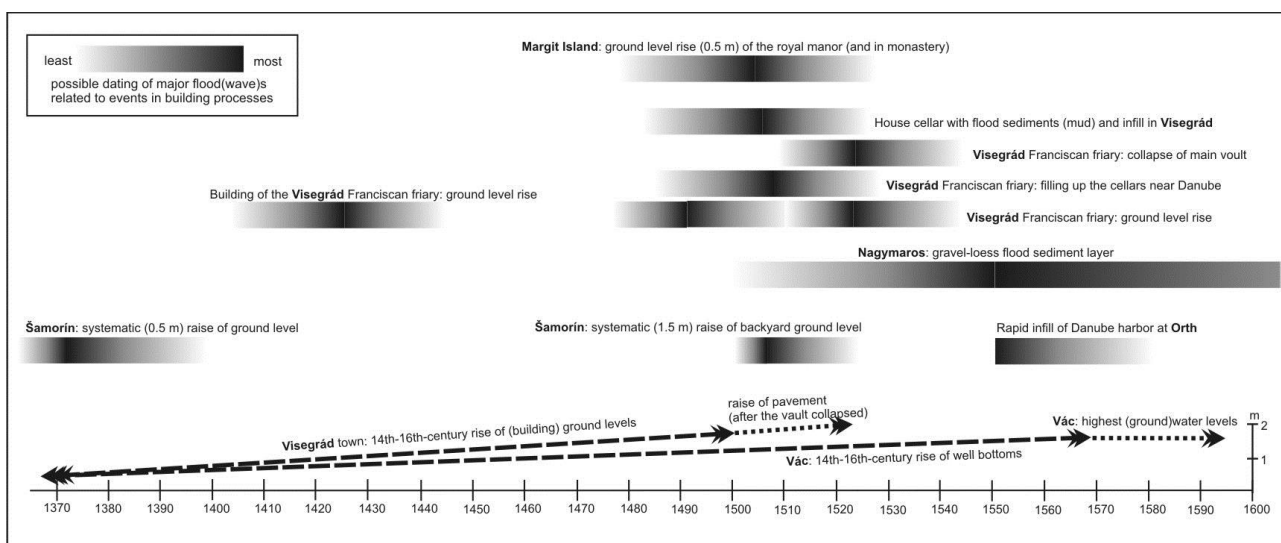
Fig. 4 An overview of 14<sup>th</sup>–16<sup>th</sup>-century Danube flood related archaeological-sedimentary evidence in the West and Central Carpathian Basin

As for a conclusion and discussion of results, it is useful to have an overview of the evidence listed above according to main reference periods (see Fig. 4).
